September 24, 1973

REPORT ON SKYLAB-M551 SAMPLES  
CONTRACT NO. NAS-8-28725

SPECIMEN PROCESSING

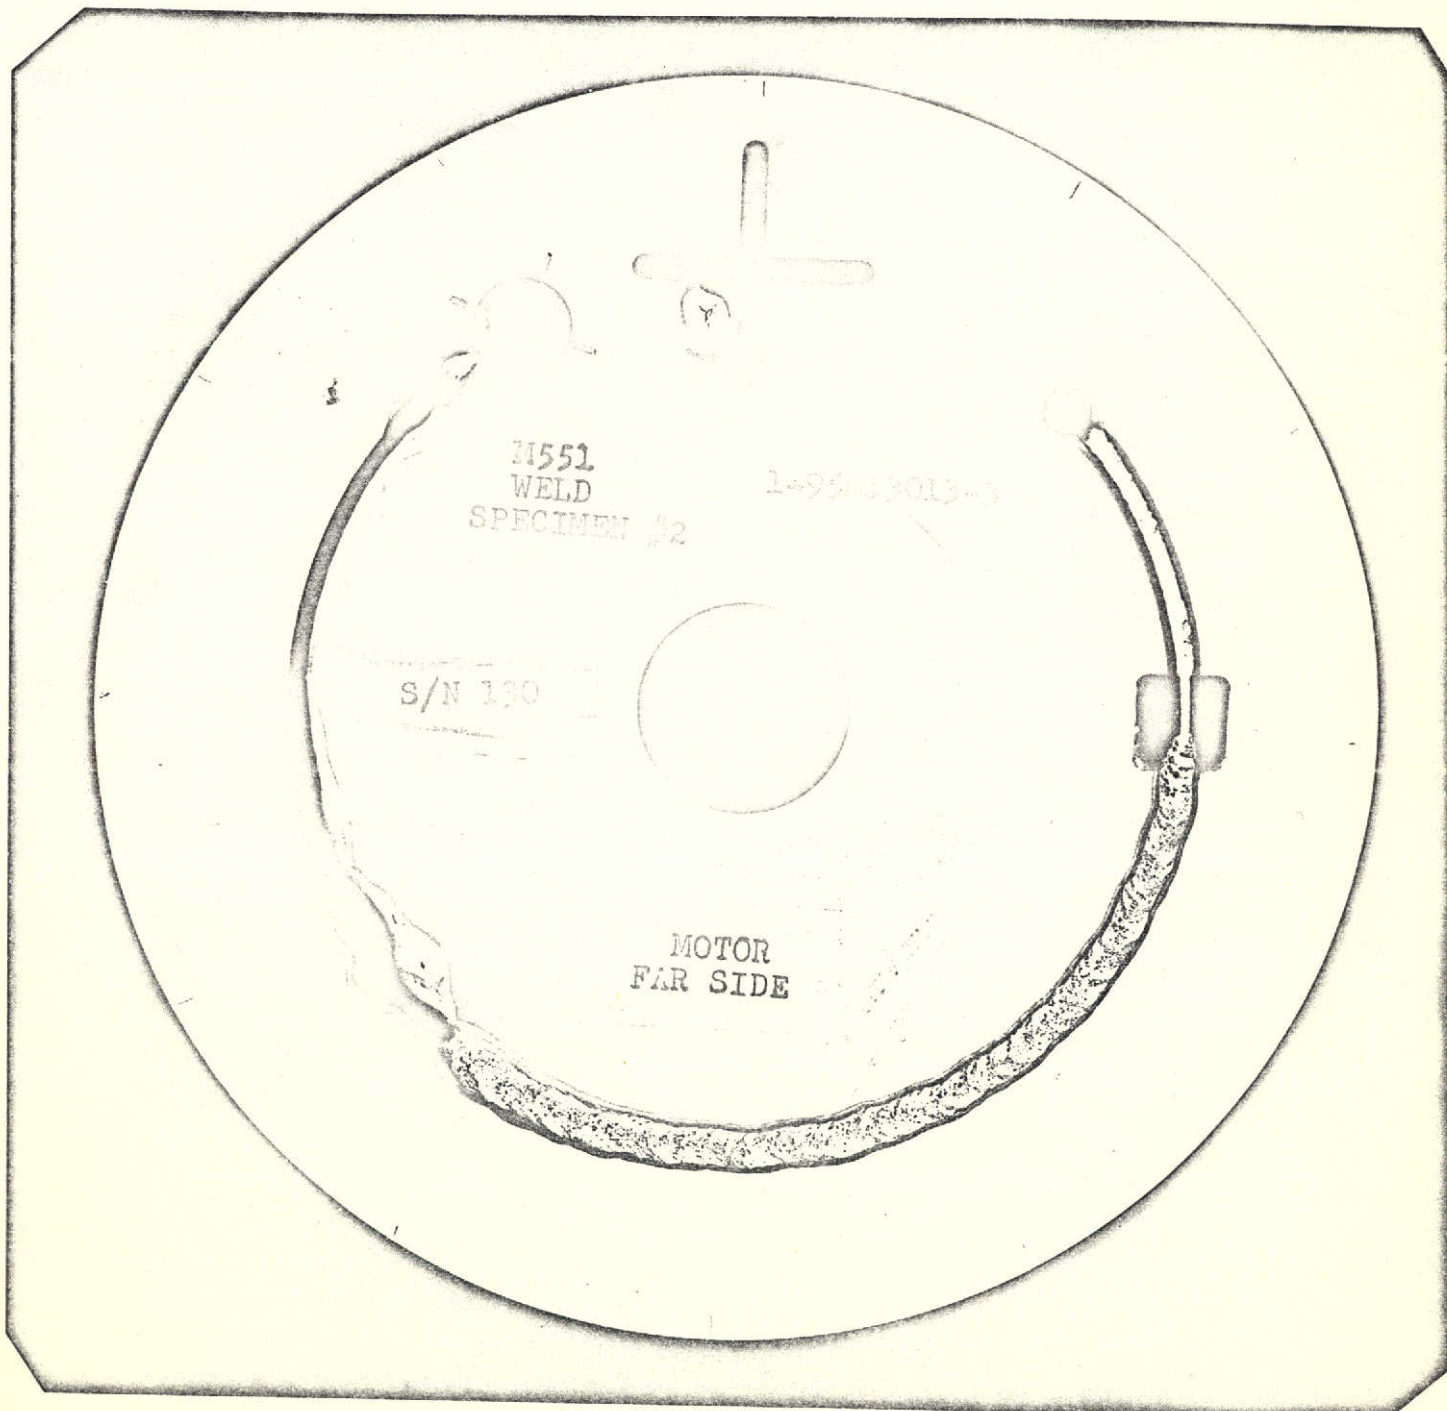
FIGURE IV-1. FRONT SURFACE S/N 130

Front Surface S/N 130

At 0 degrees the target shows good positioning of the electron-beam; almost exactly dead center. There is a short weld region on the tungsten which is not contaminated by aluminum which did flow back onto the outer edge of the target for a short distance. A short length of weld then exists up to the point where cutting starts. There is a shrinkage crack in the termination of this short length of weld. The initial width of the cut region is 6 millimeters. For most of the rest of the cut the cut narrows to approximately 2 millimeters in width. Material from the cut region formed a bead on either side of the cut. This bead is much heavier on the inside edge of the cut. Several more massive accumulations of molten metal exist along the cut region. One at about 20 degrees, one at about 70 degrees, and one at 95 degrees. The region between about 80 and 100 degrees is very erratic in appearance with the cut width varying considerable and a very massive ball of molten material on the inside edge, as mentioned previously at 95 degrees. Welding starts at about 100 degrees with only a very slight indication of a starting crack. Weld ripples are fairly pronounced although the surface is quite molted with a brownish spot-type deposit in the center region with a dark appearance on the outer region of the weld. The weld continues fairly uniform in appearance until the molybdenum tracer region is reached. Initially at that point there is a depression in the weld surface and numerous small hairline cracks are apparent in this area. Once

the weld passes by the tracer region, it again assumes a uniform appearance with clear surface ripples and very little evidence of the brown spotty material in the center. The center region for the remainder of the weld is basically bright and clean; the brown material appears to have remained along the edges of the weld. The weld terminates in the finish hole with some slight cracking in the weld crater. The initial weld width is 8mm, it then narrows to 6mm (full penetration) then to 4mm (partial pen). The dwell region was focused slightly to the inside and beyond the intended 330 degrees. The bulk of the dwell which is basically circular in appearance, is completely outside of the two legs of the molybdenum target. The dwell extends under these two legs but does not appear to have reacted with either leg very much. There are a number of shrinkage cracks in the center of the dwell region which is depressed. In general, the dwell periphery is raised above the surface of the plate being approximately even with the surface at the top. The center of the dwell is quite bright with the outer fringes of the molten zone appearing with a light brownish surface coloring. The dwell measures 15 X 12mm.

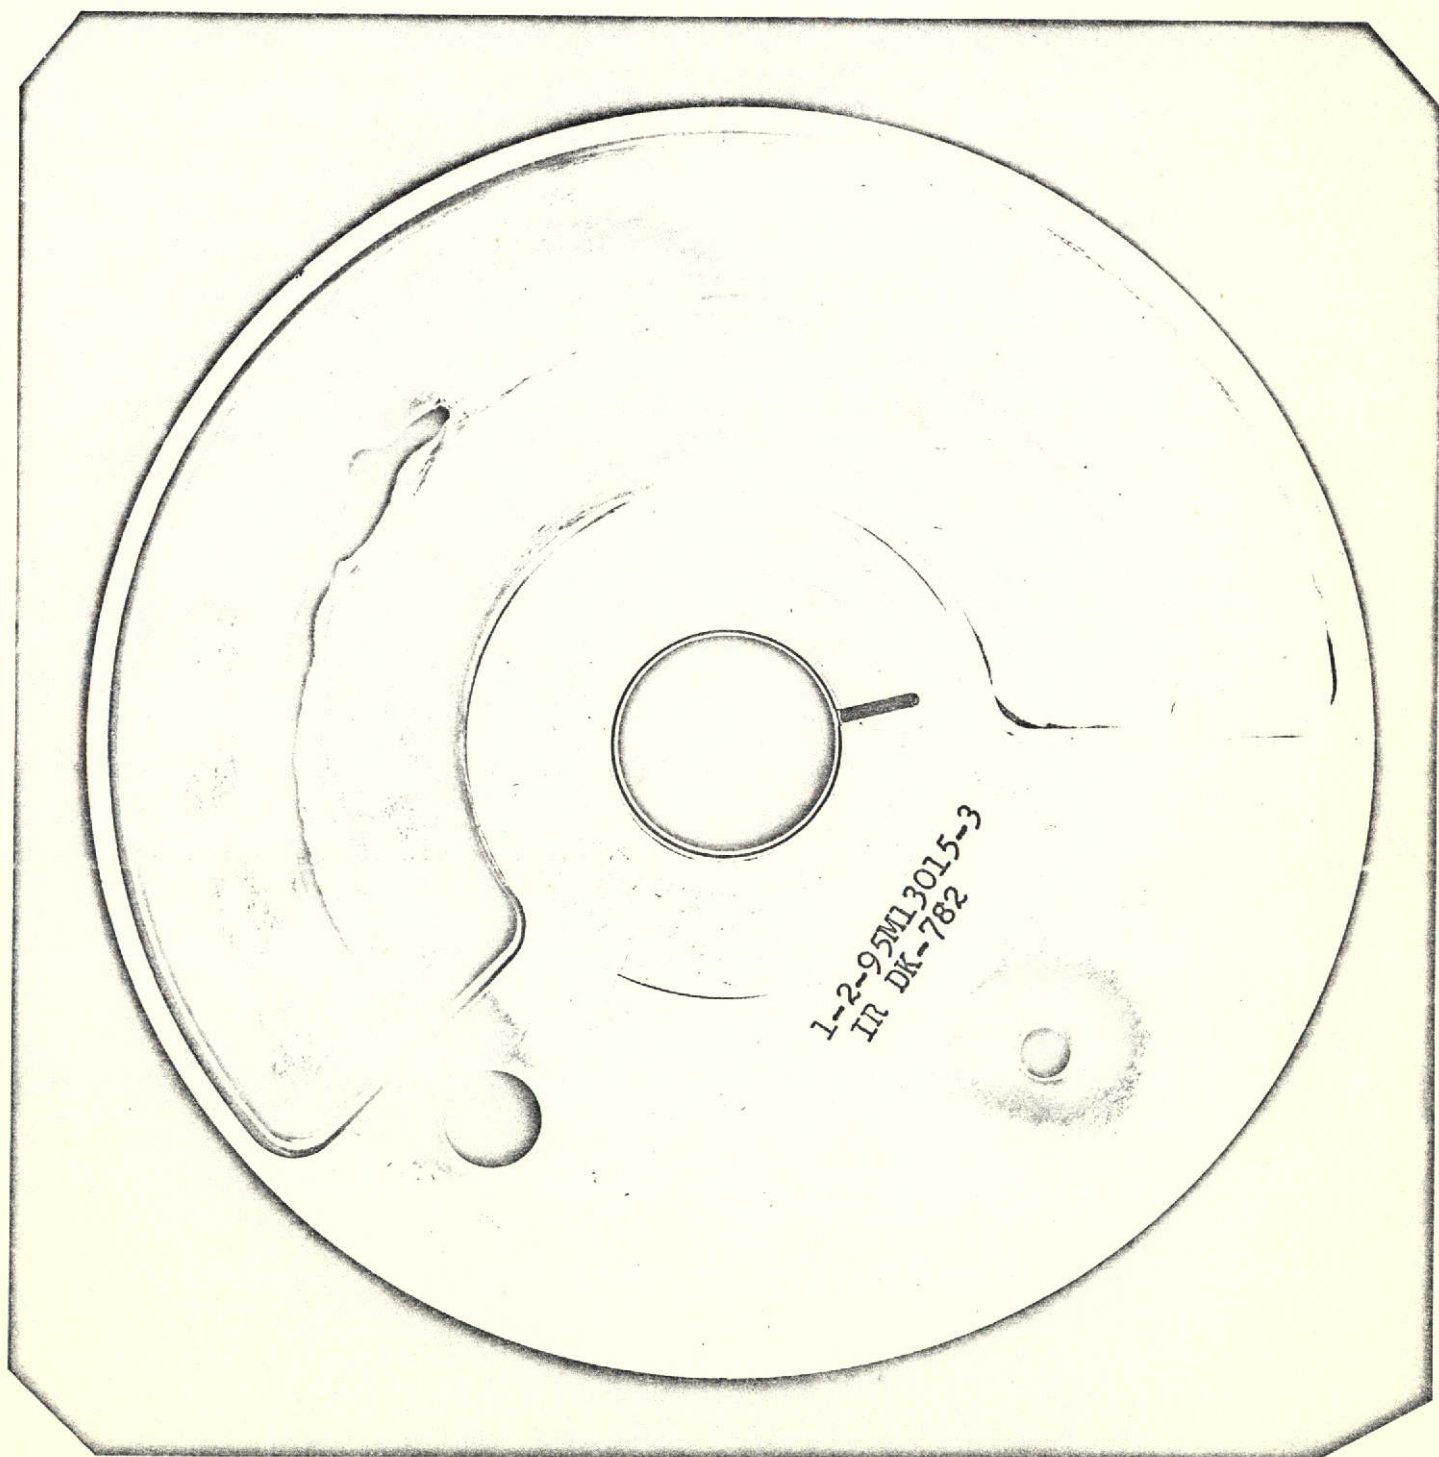
FIGURE IV-2. BACK SURFACE S/N 130

#### Back Surface S/N 130

At the target there is nothing of significance. The cur area looks much like the top surface but is not as smooth nor is there as much molten metal attached below the plate surface as on the top. The inner surface is much dirtier than it is at the top. When welding starts, there is no evidence of the hot tear on the under surface. The initial width of the weld on the under surface is quite wide, measuring approximately 8 millimeters. At about 140 degrees the width narrows to about 5 millimeters and stays essentially at that width throughout the remainder of the full penetration section. Throughout this region the under surface is somewhat erratic in appearance. There is a small crack evident at the termination of the full penetration weld. There

is no indication of welding on the partial penetration region except that the area around the termination hole is slightly discolored. There is essentially no evidence of the dwell region on the back side of the plate. A slight indication of the existence of this region can be seen without magnification. There is no difference in the surface appearance when looked at through the microscope.

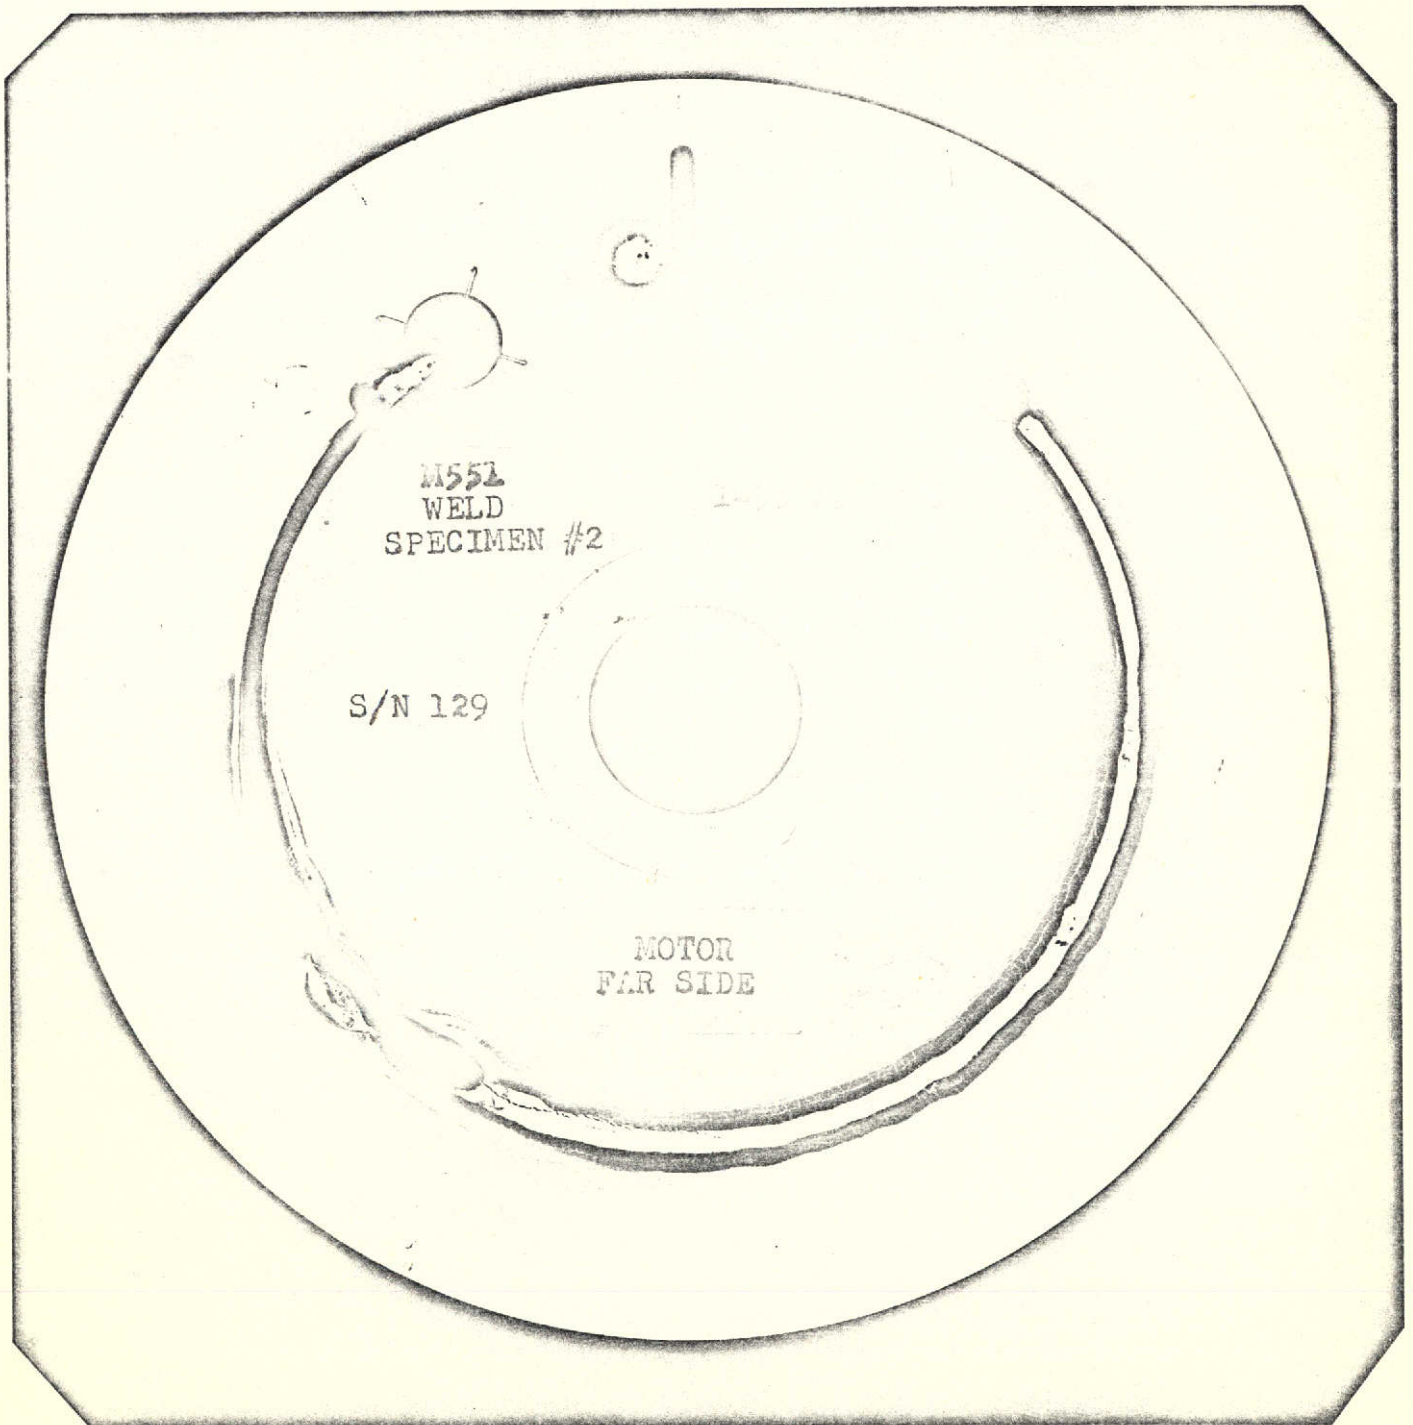
FIGURE IV-3. FRONT SURFACE S/N 129

Samples S/N 129 (Skylab) and S/N 130 (ground) are shown in Figures IV-1 through IV-4. The most significant difference in appearance is the change in the surface along the full penetration region. The skylab samples (Figure IV-3) exhibits a bright center region free of oxide. In contrast the ground characterization sample (Figure IV-1) is covered with small oxide particles. These particles are believed to be transported from the back surface of the disc by gravity induced convection. Initially both surfaces of the aluminum are covered with a thin film of aluminum oxide. The oxide on the front surface is removed from the weld center by impingement of the electron beam. Oxide on the back surface is not subject to the same conditions and is free to interact with the molten aluminum weld pool. In a gravity field the lower density oxide will tend to float to the highest point in the molten weld pool which is on the front surface. In fact, all of the ground characterization samples have exhibited evidence of this occurring where a full penetration weld was obtained. In zero gravity, the density difference is not a factor, and consequently, oxide remains on the back surface.

Front Surface S/N 129

At zero degrees, the target shows evidence of aluminum material which has run back onto the target area for a distance of about 3-1/2 millimeters. The initial weld area, which is solid, is approximately 7 millimeters in length. At this point, the cutting action begins as intended. The initial width of the cut region is 6 millimeters. Throughout the rest of the cut, the kerf narrows to approximately 2 millimeters in width. Material from the cut region has formed a bead on either side of the cut. This bead is heavier on the inside edge of the cut. At about 80 degrees, there is the first large ball of material which occurs on the inside edge. At about 90 degrees, there is a large ball of material collected on the outside edge of the cut. At 120 degrees welding starts. For the initial portion of the weld there is a hot tear along the weld centerline. The initial upper surface of the weld is relatively rough. The hot tearing condition continues until about 150 degrees. Surface roughness is still apparent and the weld surface is not depressed, but actually raised. At approximately 230 degrees, cracks are again on the upper surface at this point and between this point and 240 degrees there is some depression of the weld surface apparent. Cracks are evident and traces of the molybdenum tracer present in this region are apparent on the weld surface. The first evidence

of ripples on the weld surface occurred just beyond about 240 degrees. Weld appearance is fairly uniform from this region on to the termination hole. There is a small crater crack at the termination hole. The weld surface ripples are more apparent in the partial penetration region of the plate. Throughout the length of both the cut and weld region, there is apparent continuous cracking of the oxide film on either side of the weld. This film has a brownish appearance. The dwell region appears to be centered approximately 5 degrees off of the intended centerline and about 2 millimeters outside of the intended focal point. There is some cracking evident in the dwell region. The dwell measures 16 millimeters in length in the radial dimension and 20 millimeters in length along the chord dimension. The dwell is oval in shape with a slight depression at the center.

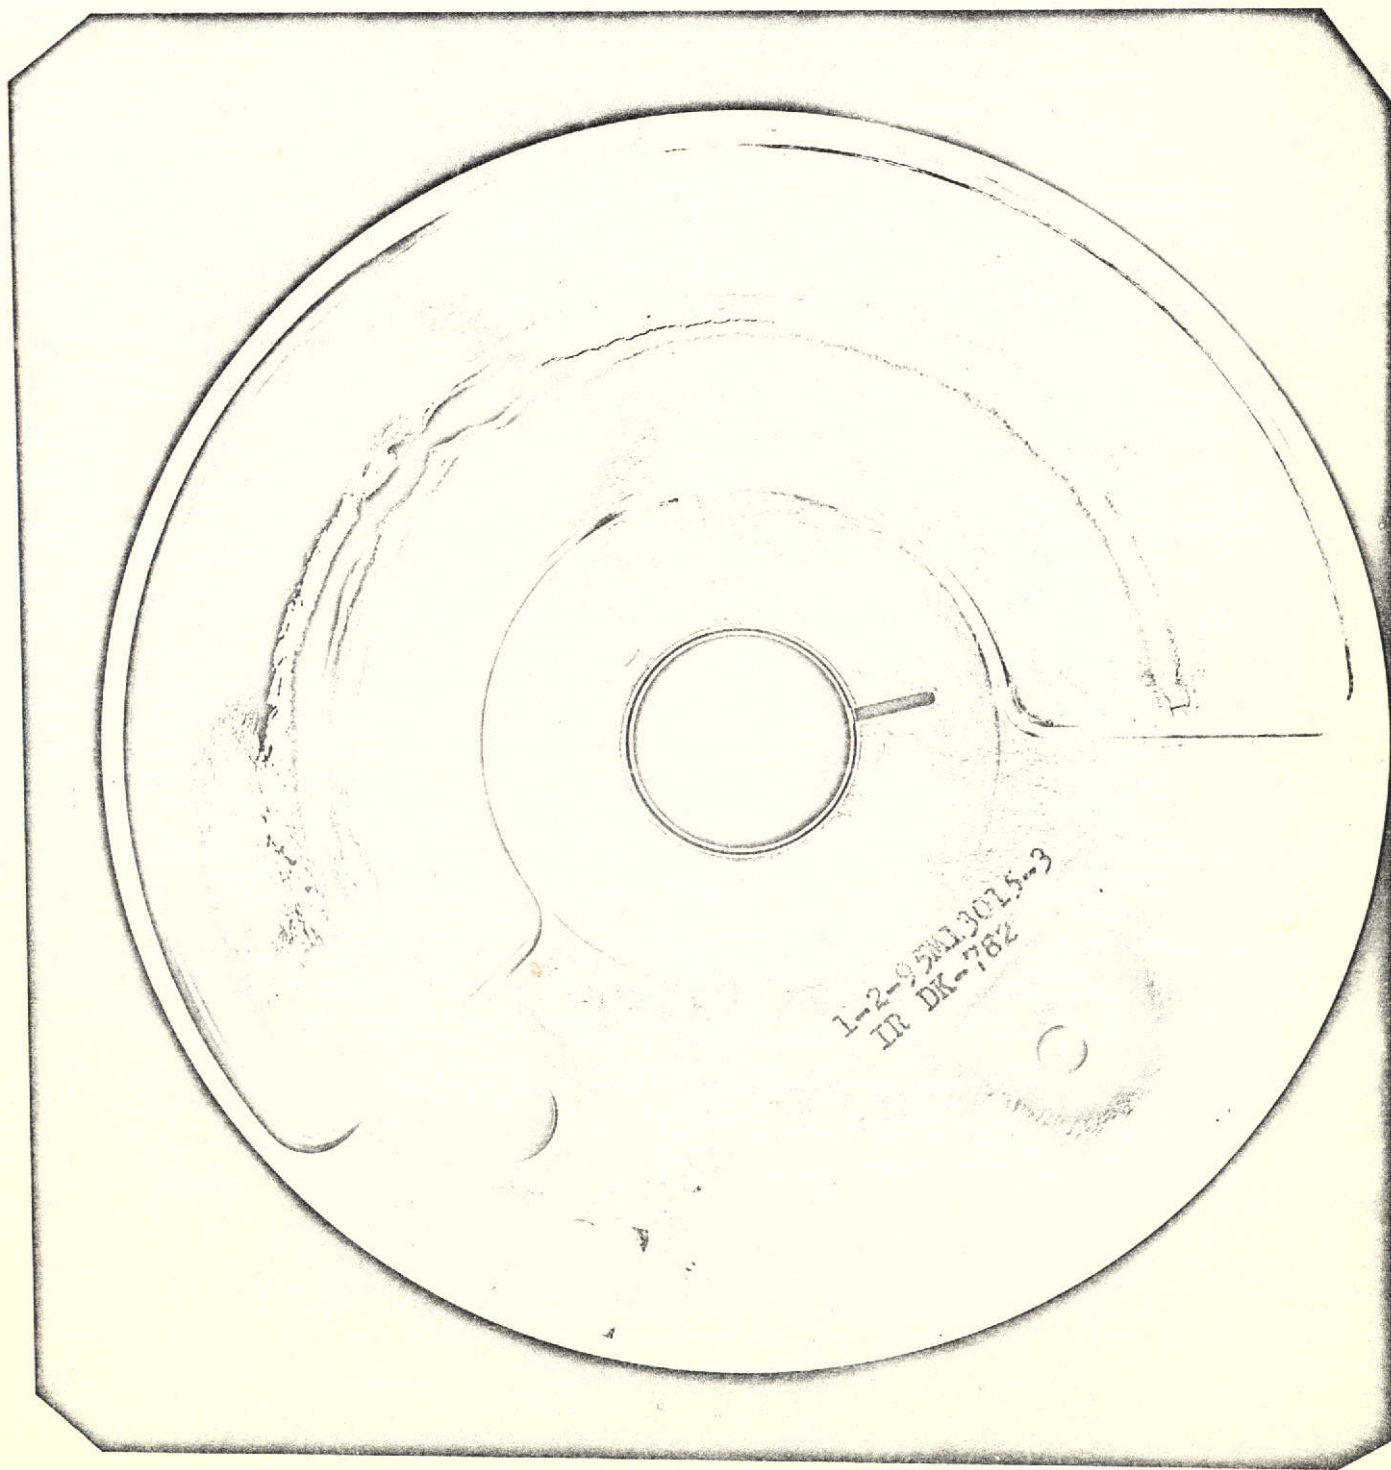
FIGURE IV-4. BACK SURFACE S/N 129

Back Surface S/N 129

At the target there is nothing of significance. The cut area looks very much like the top surface but is not as smooth and to some degree, looks a little dirtier. Where welding starts, the hot crack is apparent on the undersurface extending from the start of the weld until approximately 150 degrees. Ripples appear to be evident on the under weld surface starting at approximately 180 degrees. These ripples are quite elongated. Small check like indications in the heat affected zone are evident between 210 degrees and about 225 degrees. These are possible heat-affected zone

cracks, but this cannot be confirmed visually. The cracks evident on the top surface at about 240 degrees are also evident on the lower surface. From 240 degrees to the weld termination hole, there is no evidence of welding, however, the area around the hole itself is slightly discolored.

In the dwell region there is no absolute evidence that melting occurred through to the back side. This region is slightly different in appearance from the remainder of the plate with the machine markings being not quite as clear. It would appear that the surface of this region has a fine grained structure.

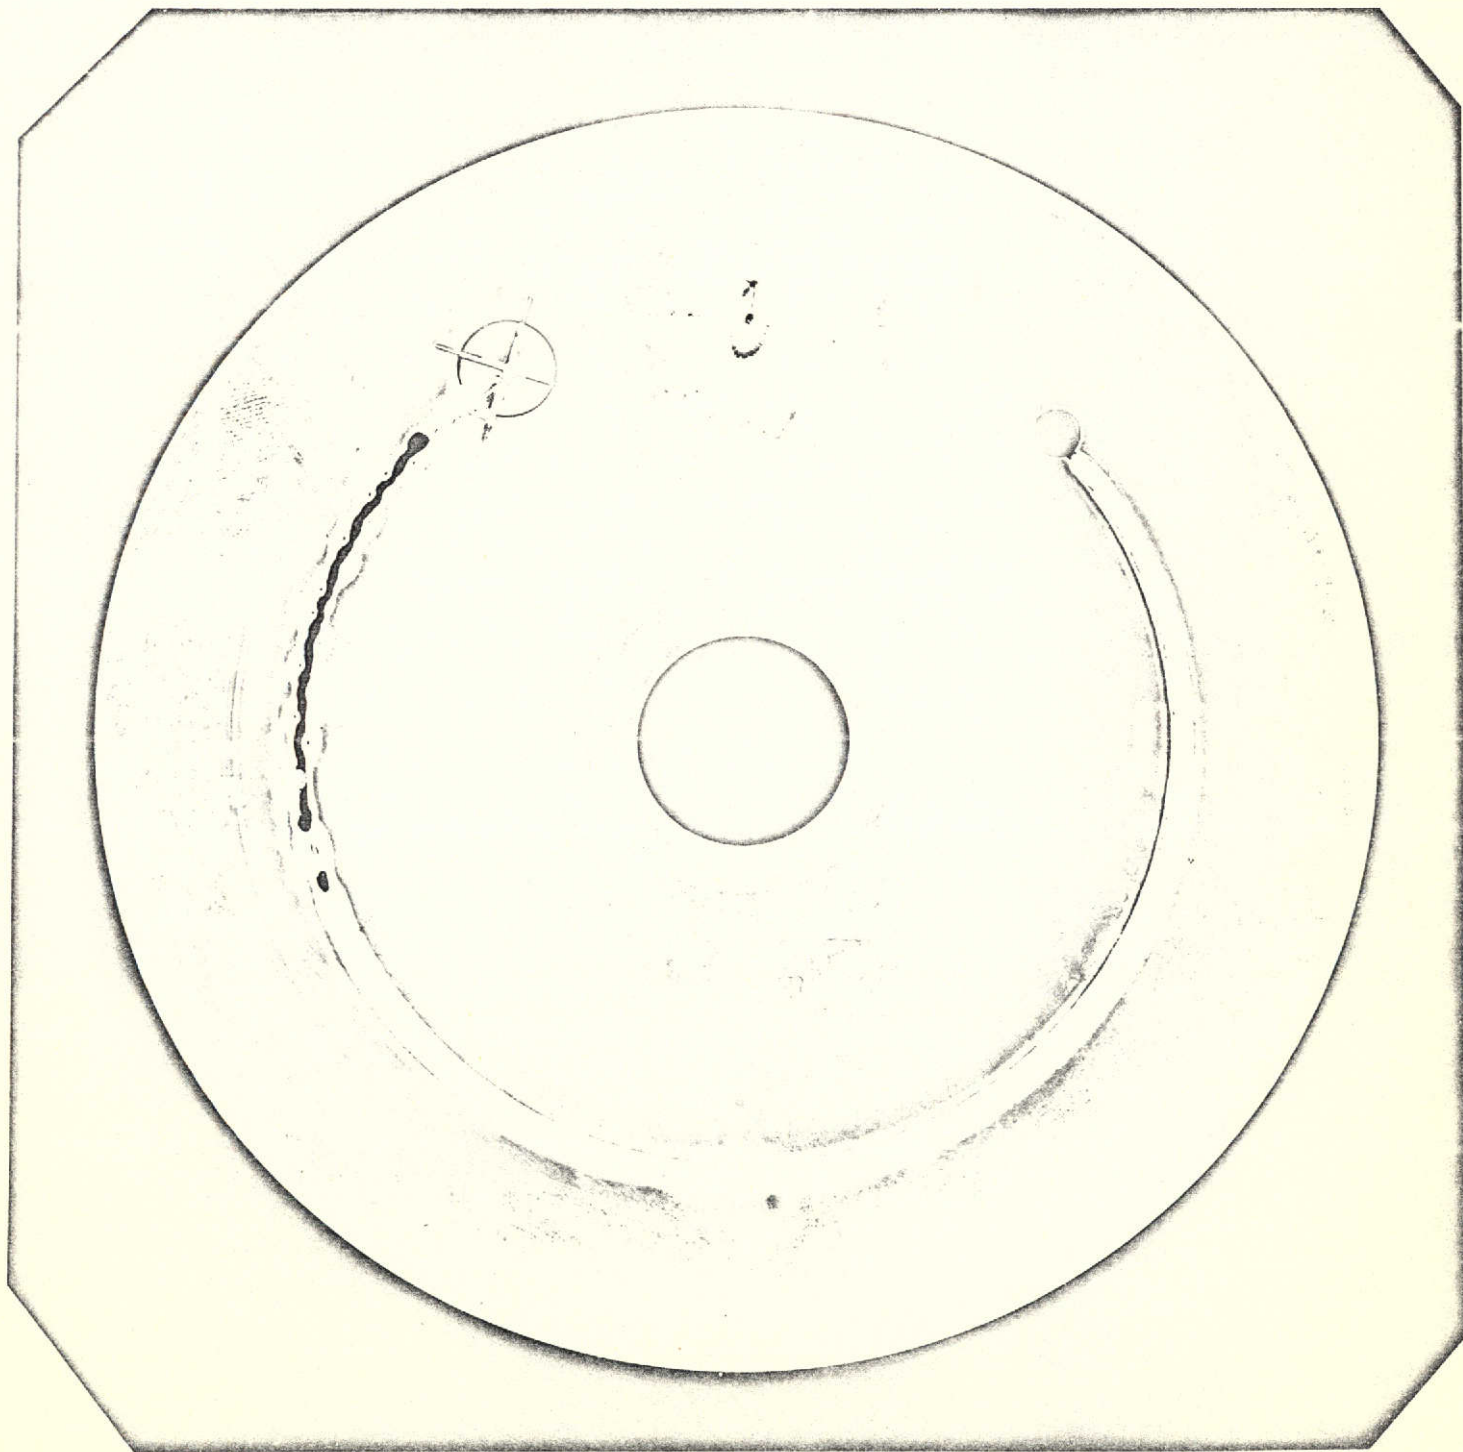
FIGURE IV-6. FRONT SURFACE S/N 106

Front Surface S.N 100

At zero degrees, the target shows evidence of having been used to locate the beam with a slight melted region almost exactly on the center. The flow back of the weld appears to extend all the way from the edge of the target back to the center. Another region on one of the grooves appears to contain molten stainless steel which has flowed back in almost a brazing type flow. The surface of the tungsten shows evidence of having reacted with this stainless steel and also evidence of two cracks - one on either side of the main weld deposit. A solid weld region extends from the target to the point where the thickness decreases and cutting commences. The appearance of the cut on stainless steel is quite different from that in aluminum. In the stainless steel, the molten metal from the cut region has accumulated periodically in essentially circular type balls. The first ball appears on the inside surface of the cut, followed by a large ball on the outside, another on the inside, and another on the outside. The width of the cut tends to vary considerably ranging between 1 and 2 millimeters. The pattern of the ball deposits being on the inner or outer cut surface is fairly uniform throughout the length of the cut region. At approximately 70 degrees, there is a complete bridge across the cut region. This is followed by one small hole and immediately followed by the start of the full penetration weld. As soon as the weld initiates, surface ripples which are very elongated, are immediately apparent. After an initial variation in the width, the weld is quite uniform in appearance until about 105 degrees. At that point, a rather severe undercut condition develops along the inside edge. This undercut appearance continues essentially unchanged for the remainder of the weld. There is no similar

evidence of undercutting on the outside edge of the weld, and no significant variation in weld appearance from the initiation of the undercut condition until its termination at the hole. There is slight evidence on the opposite side of the hole of the electron beam having been on when the disc was rotated to that point. There are occasional instances where small spatter particles can be seen adhering to the inside edge adjacent to the weld. Surface appearance of the weld is typical for a stainless steel electron beam joint with evident dendritic patterns at higher magnifications. There is no evidence whatsoever of any cracking or weld defects other than the undercut. The focal point for the dwell area appears to have been almost exactly at the center of the molybdenum tracer target. It is slightly inside but still within the target region. The dwell is elongated - the long axis essentially parallel to the radial direction. There is an obvious buildup of material above the surface surrounding the entire dwell region. Solidification ripple patterns are quite evident along this built up region. The center portion of the dwell shows no evidence of ripple patterns for approximately half of the total area. A large cavity and crater are evident at the center of the dwell. The dwell measures approximately 19 millimeters along the long axis and 10 millimeters on the short axis.

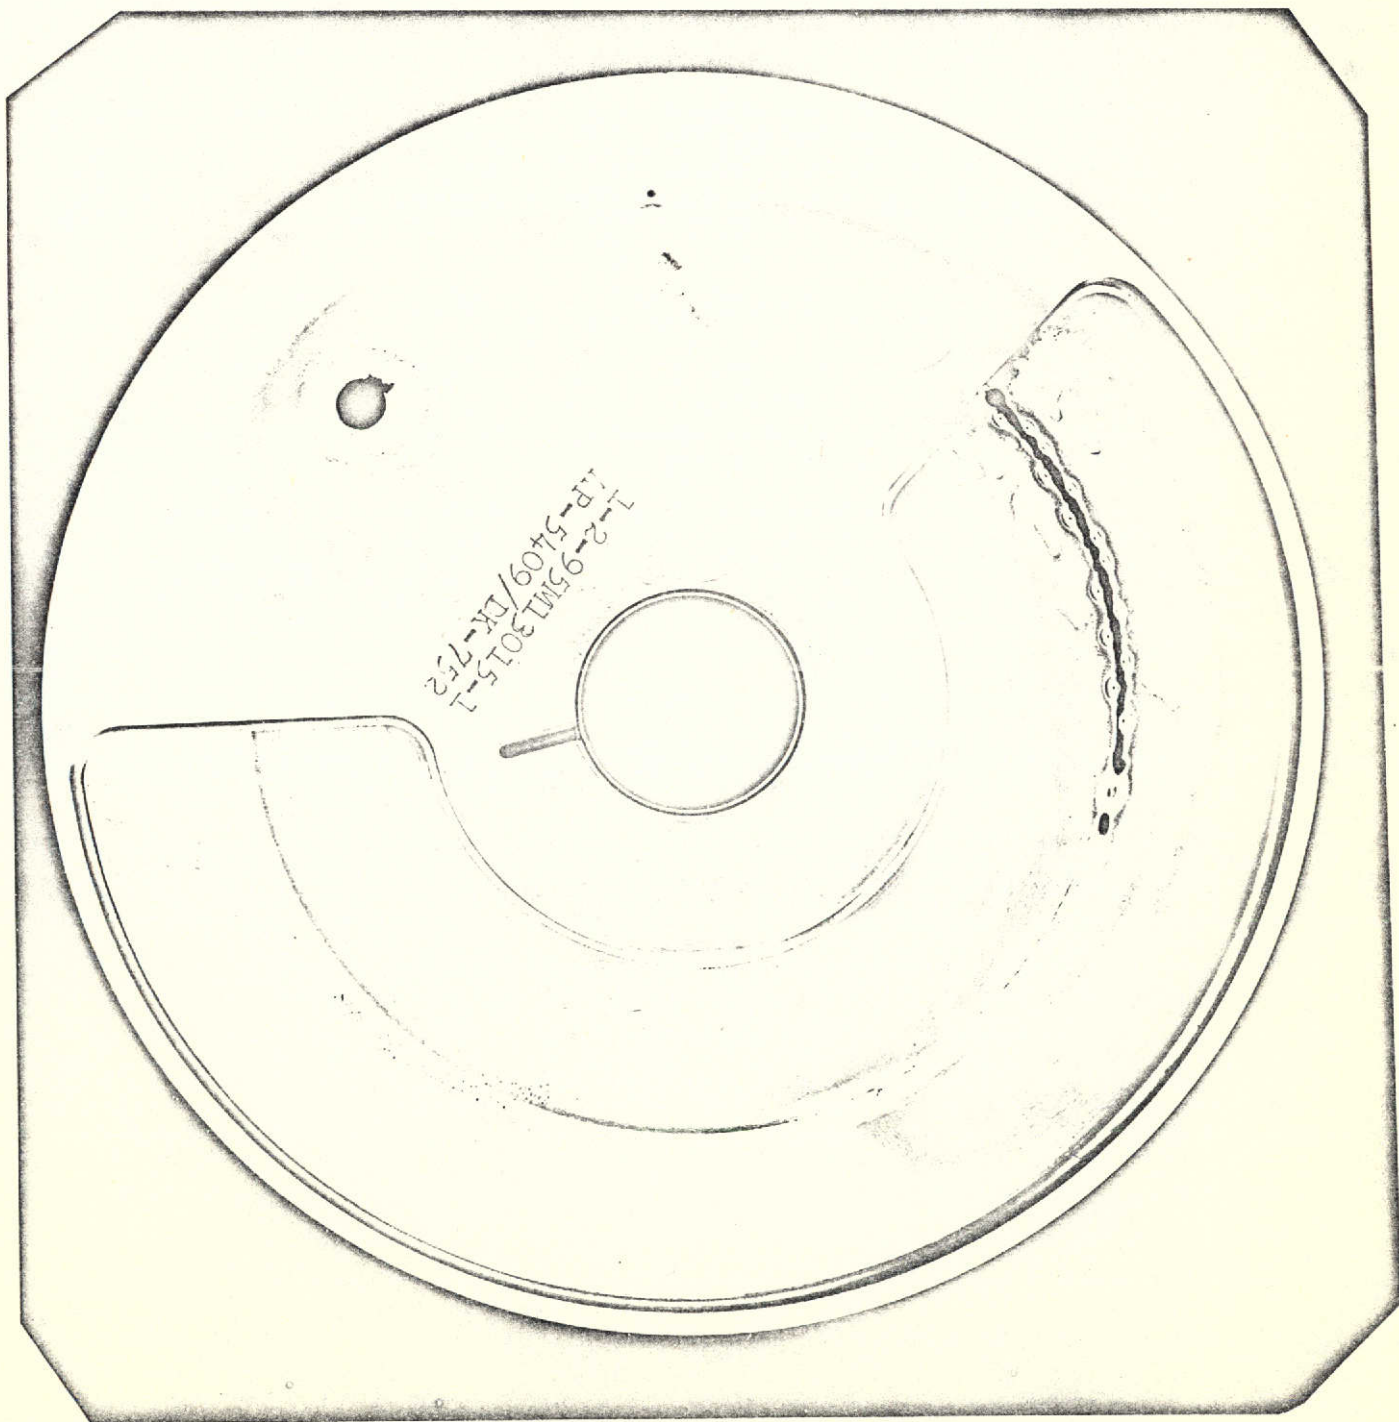
FIGURE IV-7. BACK SURFACE S/N 106

Front Surface S/N 106

The target area indicates nothing of significance except slight brownish discoloration. The cut region starts immediately when the thin section is reached. The appearance of the balls along the cut region is quite similar to their appearance on the upper surface, although there is slightly

more grayish discoloration on the lower surface. Where the weld commences, a ripple pattern again is immediately evident. The full penetration weld occurs with fairly uniform width penetration from the start of the weld to 120 degrees. At this point, penetration or width of the bead narrows and there is some buildup on the under surface. Full penetration stops at approximately 140 degrees. This situation continues until at approximately 200 degrees there is a single small circular indication of full penetration. It is clear on the under surface where welding has occurred, even in those regions where penetration is not achieved. It would appear that there is a slight drop through on the underside even when penetration is not clearly evident. There is no evidence of the weld on the under surface in the partial penetration region. Some discoloration is evident on the surfaces surrounding the underside of the termination hole. Full penetration was achieved on the dwell but the overall size of the molten spot is much smaller than on the top surface. Its basic appearance is quite similar with evidence of ripple formation on the edges with a single very smooth surface center region which seems to have solidified all at once. Although it is not as obvious, the region of penetration on the lower surface is also basically oval or oblong in shape. The long axis measured approximately 7 millimeters and the short axis just under 6 millimeters. The general appearance of the contour on the under surface is a very shallow depression with the edges being possibly slightly raised above the original surface.

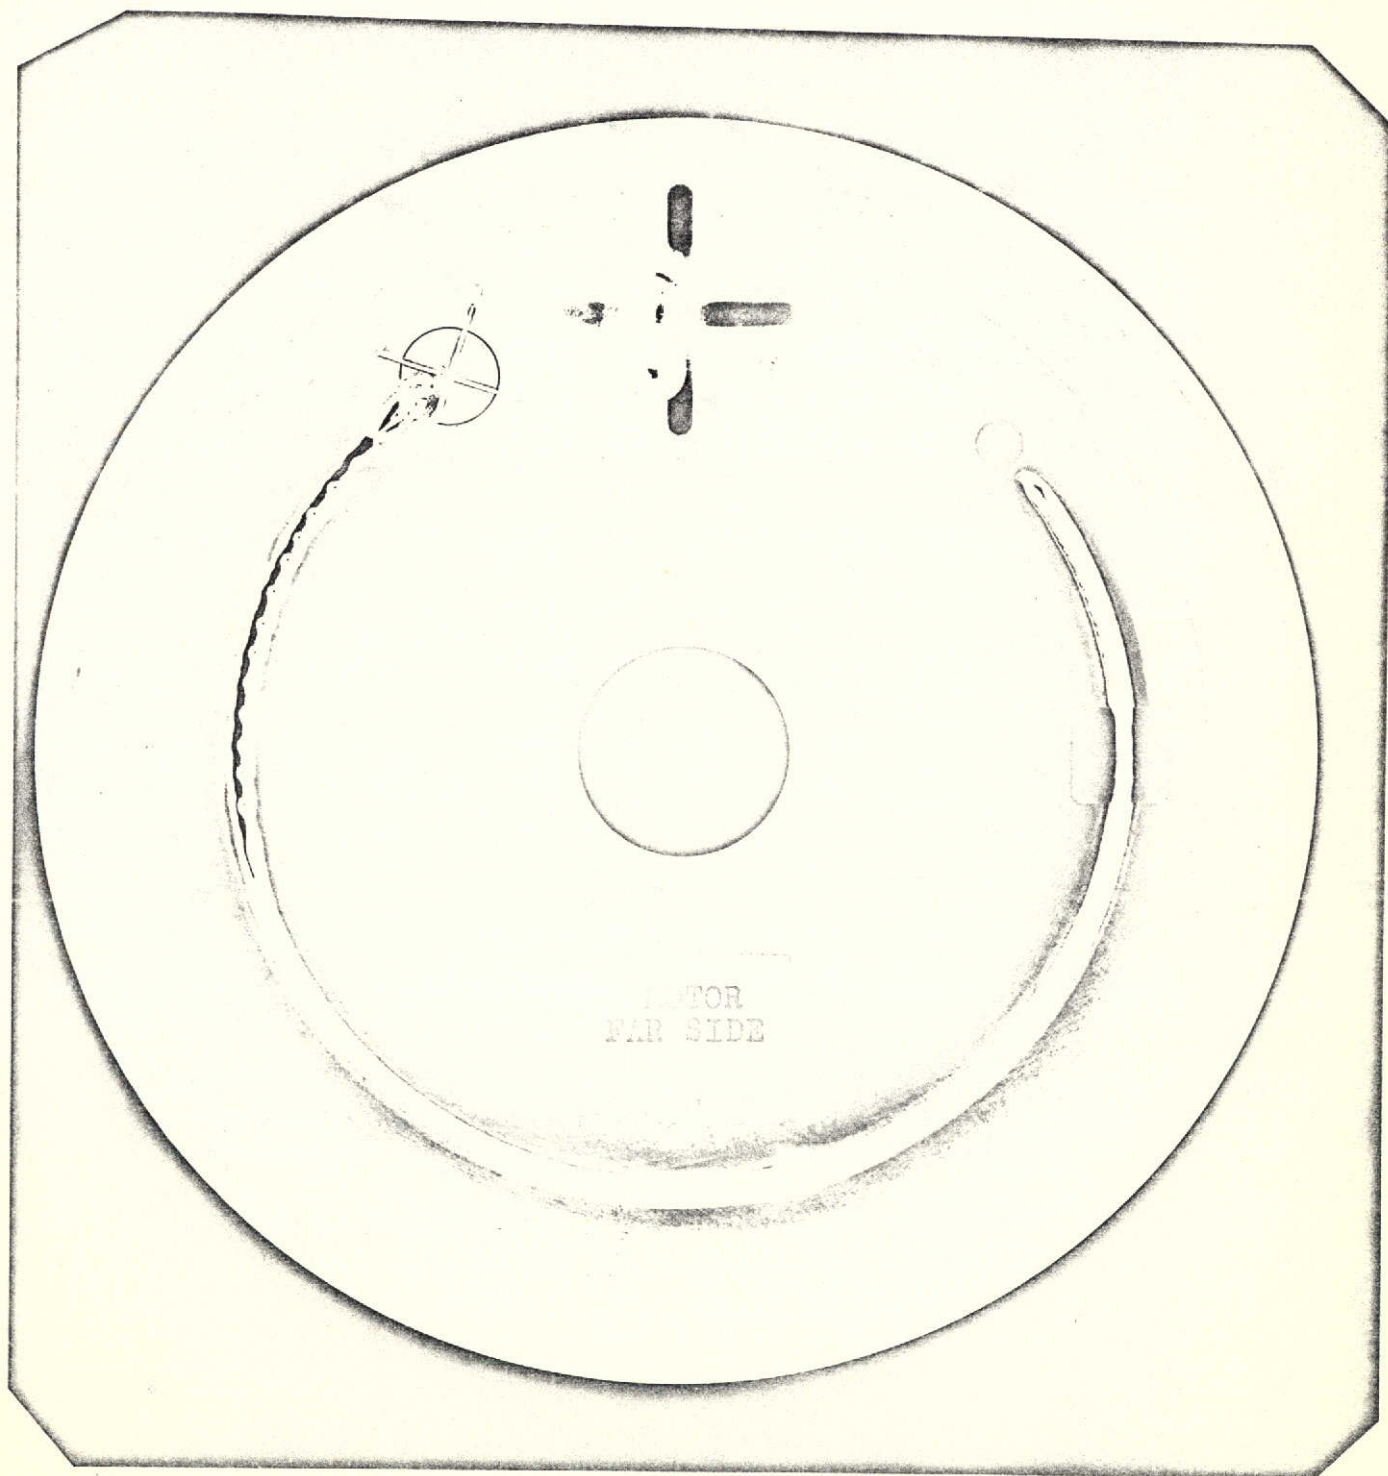
FIGURE IV-8. FRONT SURFACE S/N 110

Front Surface S/N 110

At 0 degrees the target has been used to locate the beam with a melted region almost exactly on center. Flow back of molten stainless steel has occurred all the way from the edge of the target back to the center. A solid weld region extends from the target to the point where the thickness decreases and the cutting commences. The cut width is 1mm. In the cut region the surplus molten metal has accumulated in essentially circular balls. In this specimen, all the balls lie along the inside edge of the cut region. There are 13 of the ball accumulations along this edge. The last of the ball accumulations is slightly beyond 60 degrees, although the actual welding does not start until about 75 degrees. As soon as the weld initiates the surface ripples which are very elongated are immediately apparent. Undercut along the inside edge is also immediately apparent. Starting at about 130 degrees the undercut is not as severe and, in fact, may not exist although there is an occasional indication of undercut still along the inside edge. At about 160 degrees, there is a perturbation in the surface appearance related to a mass change as the disc rotates. At the change in thickness going from the thin to the thickest material, there is a change in the bead appearance with the top surface appearing to be more elevated in the partial penetration region. The weld terminated slightly short of the termination hole with a shallow elongated crater. There are occasional instances where small spatter particles can be seen adhering to the inside edge adjacent to the weld. Surface appearance of the weld is typical for stainless steel electron-beam joint.

There is no evidence of any cracking or weld defects other than the undercut. The weld width initially is 1-1/2mm., widening to 2.5mm. (full penetration) and then to 3 mm. (partial penetration).

The focal point for the dwell area appears to be slightly on the inside and slightly beyond the 330 degree position. However, the dwell is fairly well centered on the molybdenum tracer target. The dwell is elongated, the long axis essentially parallel to the radial direction. There is a build up of material above the surface of the plate in the lower portion of the dwell melt side. The upper portion is depressed below the plate surface. A large cavity and crater are evident at the center of the dwell but slightly toward the top side. The dwell measures approximately 18 millimeters along the long axis and 8 millimeters on the short axis.

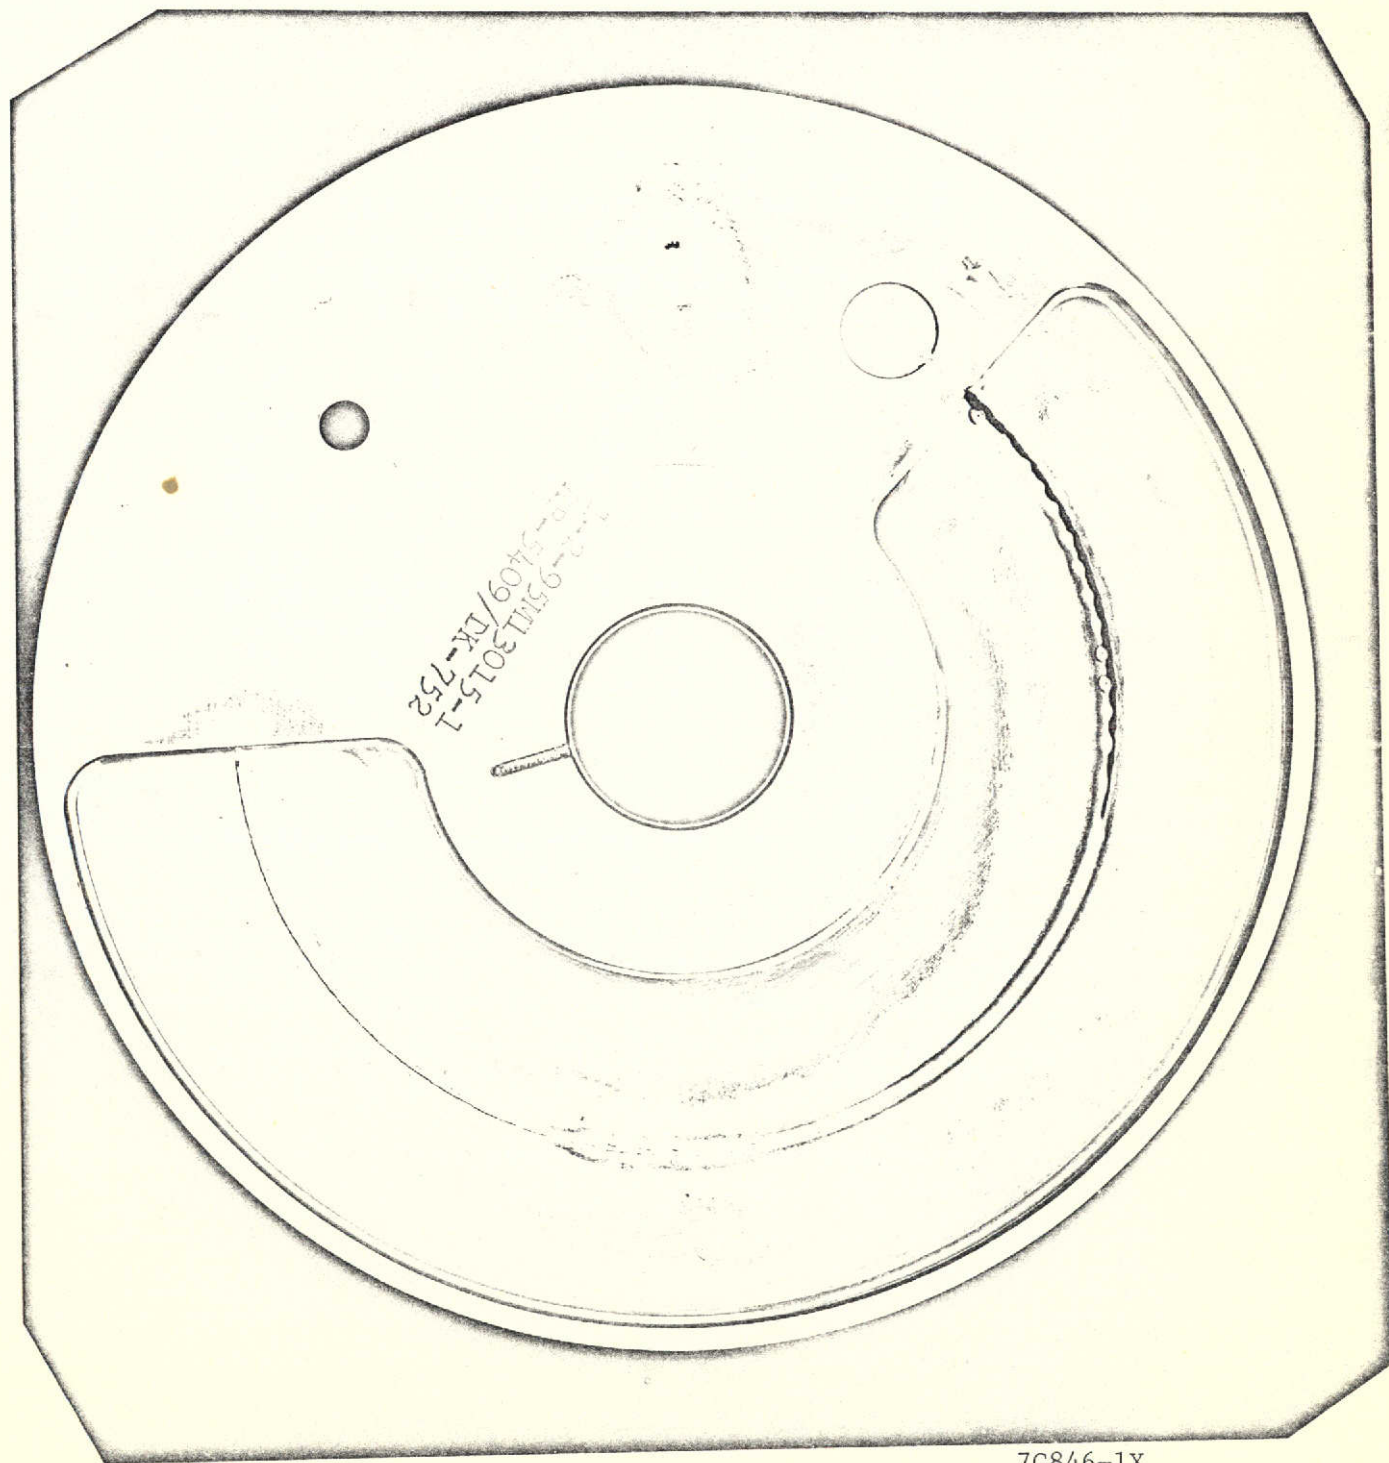
FIGURE IV-9. BACK SURFACE S/N 110

#### Back Surface S/N 110

The target area is completely melted through slightly on the surface adjacent to the weld start. Penetration proceeds for a short distance and then stops until the cut region is reached. The cut region starts immediately when the thin section is reached. The appearance of the circular balls along the cut region is quite similar to their appearance on the top surface. Where the weld commences, a ripple pattern again is immediately apparent.

Starting at about 145 degrees, there is quite a bit of evidence of spatter adhering to the back surface. The same perturbation noted on the front surface due to the mass shift is also apparent on the back surface. Penetration is continuous throughout the length of the full penetration portion of the plate. At about the same point where spatter first starts, the underside bead contour begins to change getting slightly narrower and somewhat higher

than it was in the earlier portion. There is no evidence of the weld on the under surface in the partial penetration region. Full penetration was achieved on the dwell but the overall size of the molten spot is much smaller than on the top surface. Its basic appearance is quite similar with evidence of ripple formation on the edges with a single very smooth surface center region which appears to have solidified all at once. The outermost edges of the dwell on the under surface are raised slightly above the plate surface everywhere except at the very top. The center region of the dwell is generally depressed. The long axis measures approximately 10 millimeters and the short axis 7 millimeters.
